**“REPORT on XADO  
REVITALIZANT® application in oil  
of MAAG reducer of cement  
grinding mill 3”**

Reliability department

**Operations Vice President**  
San Pedro de Macorís Plant

January 2016

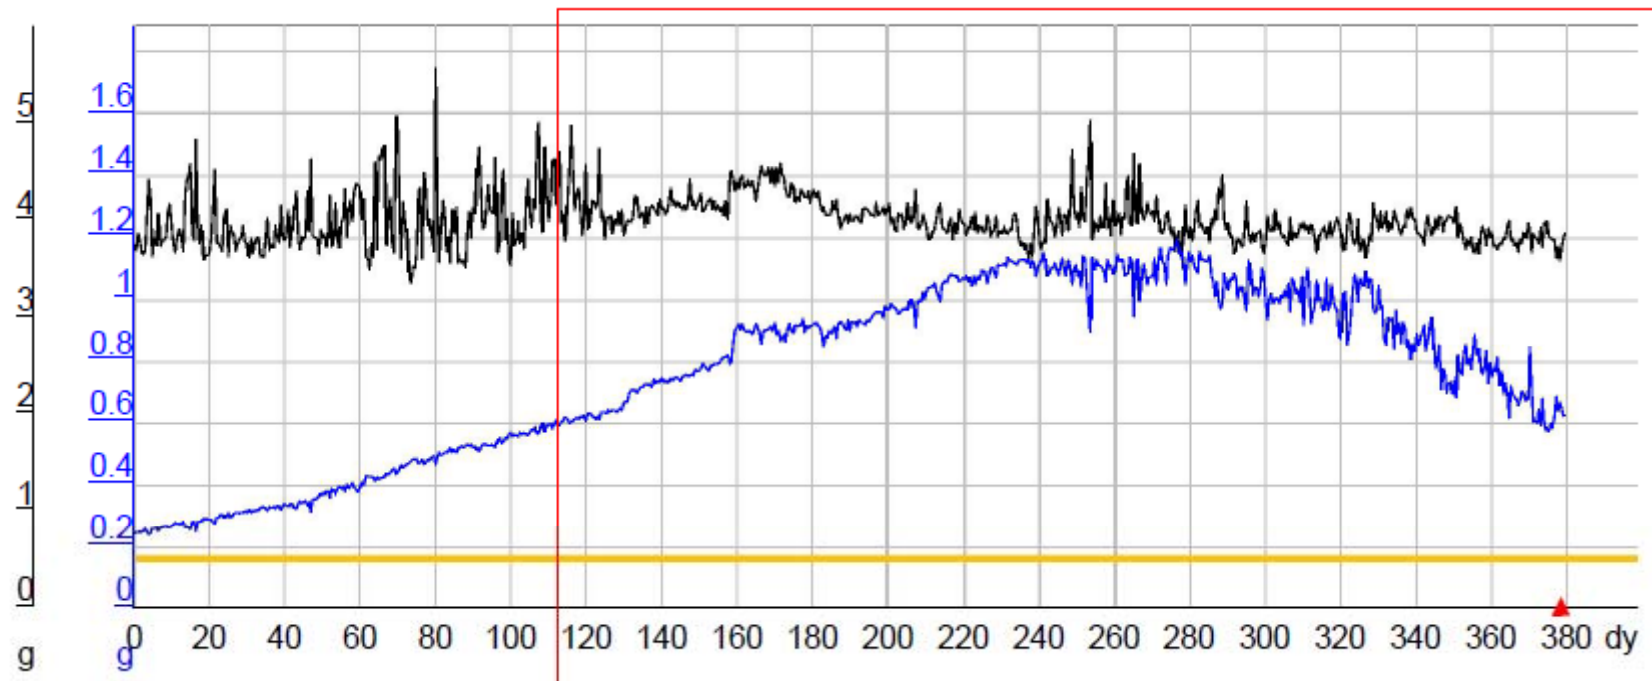
The overall vibration level has been constantly decreasing from the maximal achieved point 1.7 G's down to 0.65 G's.
